**Report No: CG-D-06-11**

# CSSC Fish Barrier Simulated Rescuer Touch Point Results, Operating Guidance, and Recommendations for Rescuer Safety

## Interim Report

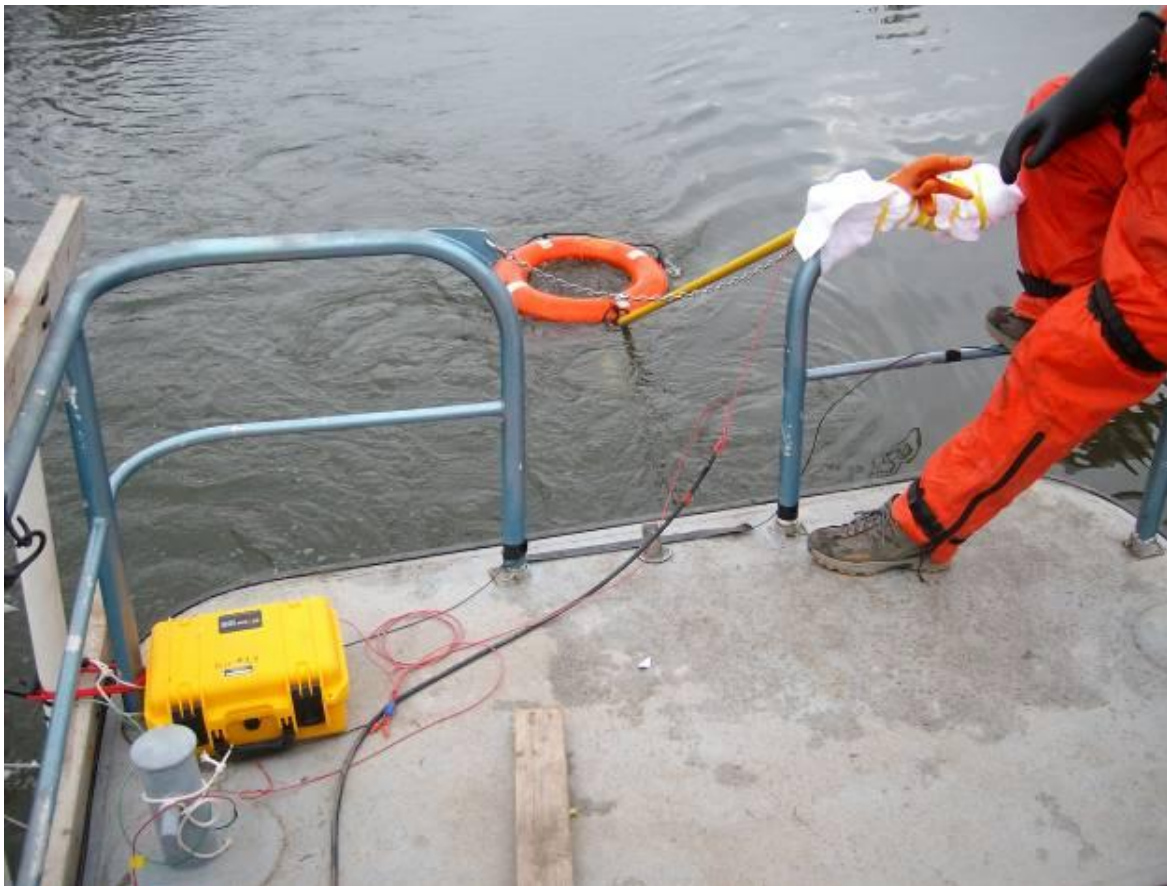
A commercially available non-conductive rescue hook (Salisbury part number 24403) with an insulated fiberglass handle served as the recovery hook for this condition. We dipped the recovery hook in the water to ensure that the surface of the handle was as wet as possible during the electrical current testing. We wrapped an input electrode around the hook to provide solid electrical contact with the simulated PIW, the water, and the end of the rescue hook. We then electrically connected the handle end (the boat end) of the hook to the hull of the test vessel to simulate a rescuer grounded to the test vessel aluminum hull to complete the electrical circuit. We then connected the hook to the life-ring to keep it near the surface. The test vessel then towed the hook and life-ring through the electrified barrier. Figure 20 shows the test vessel towing the rescue hook apparatus.

Figure 20. Test vessel towing life ring and simulated PIW with non-conductive rescue hook.

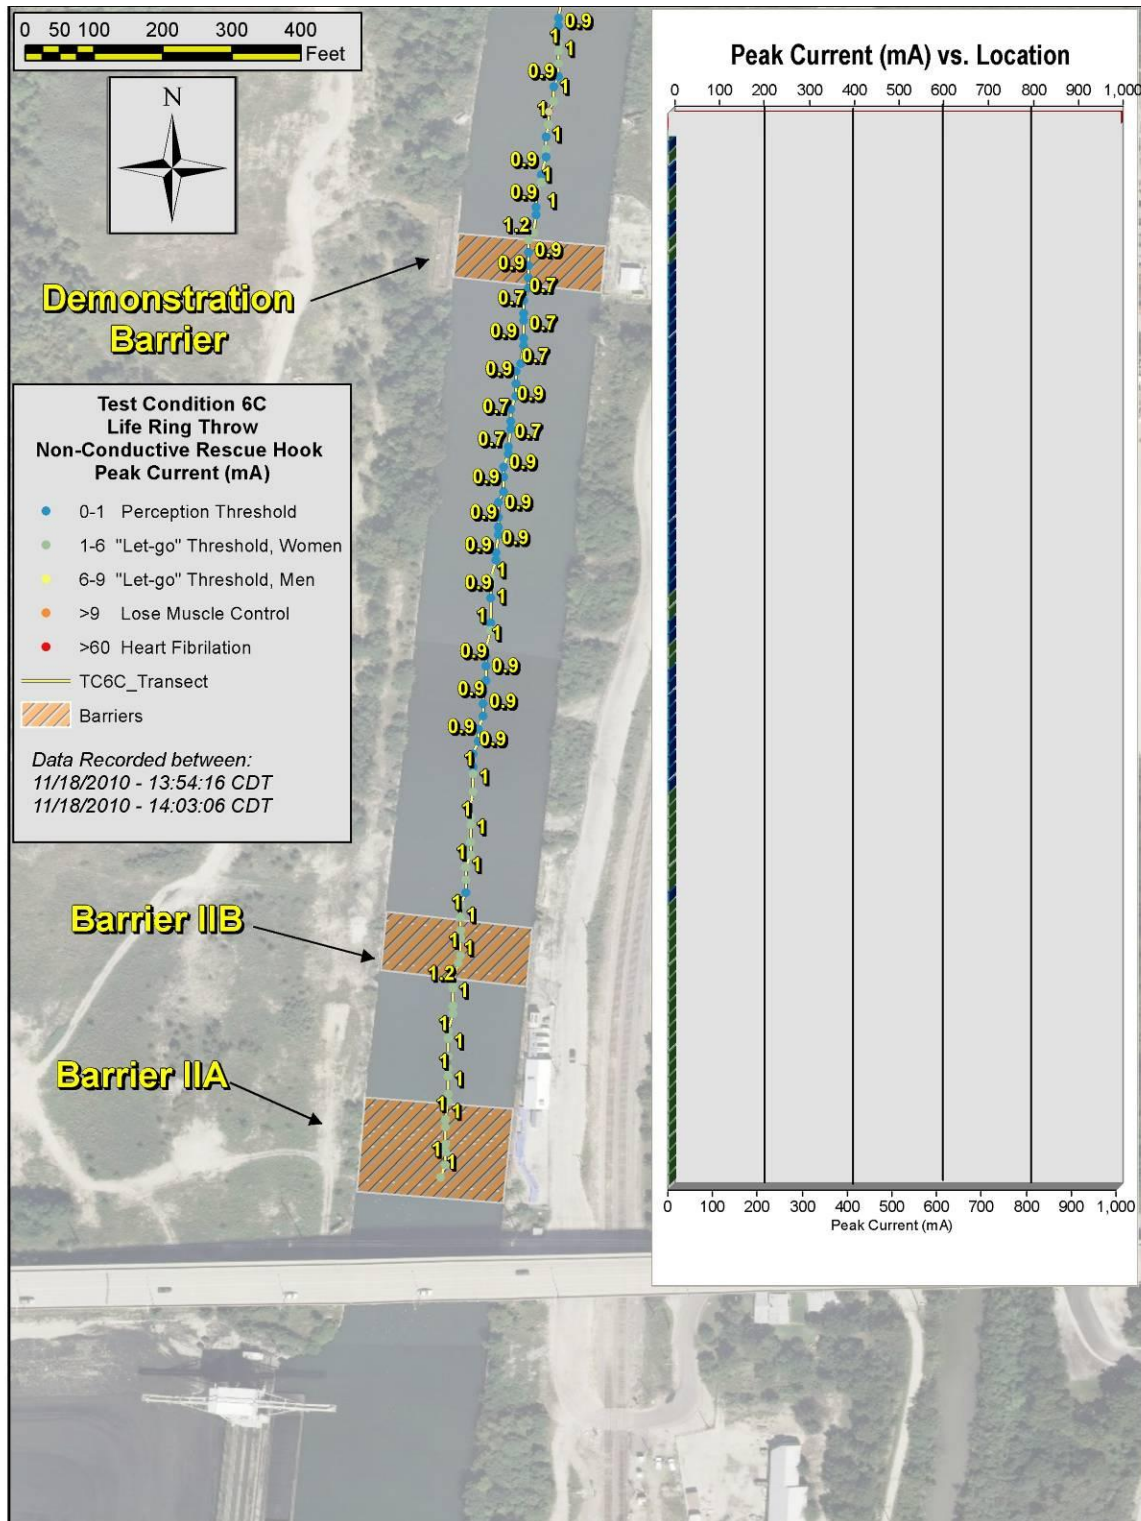
Results from this test were similar to those with the polypropylene braided line. We did not observe any peak electrical currents to the rescuer above the RMS background electrical noise of approximately 0.2 mA, or peak noise of approximately 1 mA (see Figure 21). The peak background noise levels for this test condition were slightly higher (1 mA vs. 0.7 mA for Test Conditions 6A and 6B), which was indicative of higher background noise of this electrical test setup. Pulsed waveforms were not observed above background noise in this test condition.

Figure 21. Peak electrical current through non-conductive rescue hook to rescue vessel.

Table 8 summarizes the results of Test Condition 6. Minor electrical currents were seen with a soaked braided nylon line, but produced peak currents of approximately 1.2 mA. Peak current while towing a simulated PIW from the vessel did not produce any measurable data above the background noise levels for either the polypropylene line or non-conductive rescue hook scenario.
